Structural Integrity of Fuel Storage Tanks

Abstract— Fuel storage tanks like other utilities in the oil industry are subjected to corrosion due to their content, operation conditions, and environment. Corrosion has a big impact on the integrity of the storage tanks leading to failure of the tank bottom plate and tank shell. The consequences of corrosion damage are fuel leak, tank damage and risk of fire, as well as environmental risks. The aim of this work is to investigate the actual condition of the tank internal shell, bottom plates, and to identify the cause of failure. It investigates the structural integrity of heavy fuel tanks through internal and external inspections for the tank. Visual inspection coincides with ultrasonic thickness measurements are carried out. Microstructure analysis are also conducted for the corroded areas. The results showed that the bottom plate was attacked by a severe pitting corrosion in the center of the tank with a massive loss of the plate thickness. The pittings observed were of various depths and sizes that scattered on localized areas where some of them having thorough holes. Several corrosion mechanisms could occur concurrently or separate

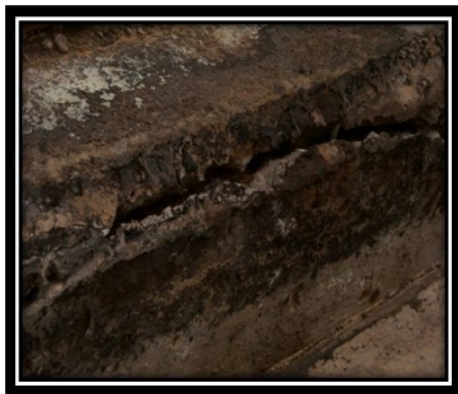
A severe cracking damage was observed along the tank concrete foundation ring as shown in Fig. 1. The cracked area showed traces of leakage of fule oil. Massive cracked area was also observed around the tank associated with fule oil lekadge.

Fig. 1 Cracked concrete foundation ring of the tank.

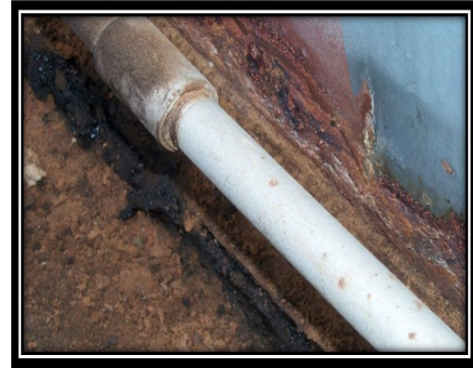
The external side of the shell was subject to svere corosion on the low level at the weld joint where the steel wall shell toughes the conceret ring as shown in Fig. 2. Howevee the above part of the shell was almost free of any sign of corrosion. this could be a result of crevice corrosion taking place since the sealing component is not installed (annular ring to foundation). Through the gap between the annular steel ring and the concrete foundation ring shows possability of mositure entering underneath.

Fig. 2 The external side of the shell svere corosion

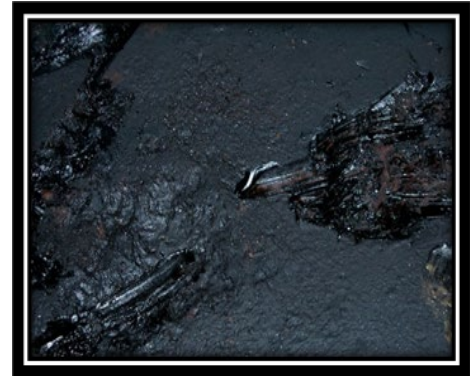
Visual inspection performed showed the presence of large thick layer of a cumulated sludge on the underneath surfaces, especially at the west side of the tank as shown in Fig. 3. Thus sand blasting was conducted to clean the bottom surface of the tank.

Fig. 3 The underneath thick sludge layer.

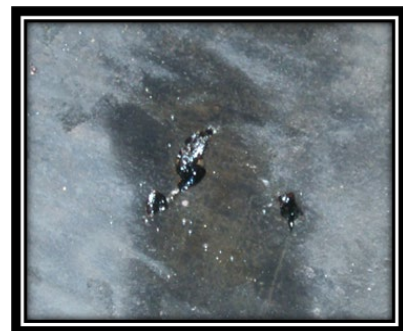
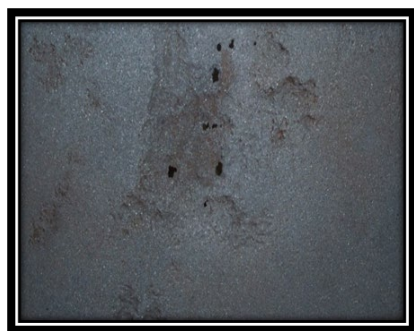
The inspection showed severe localized pitting corosion attack with different depths and sizes scattered on localized areas of the internal bottom plate, as shown in Fig. 4.(a).(b). Maximum average areas of localized pitting was 30cm in diameter with a count of 100 pits in avrage, depth average of 2.51mm, with the deepest pit was 7mm. Thorough holes were also observed in middle of tank plate and some ring bottom plates. While, the internal surfaces of some plates away from the center were free from any significant of corrosion (nearly clean surfaces) as in Fig. 5. Considerable reduction in thickness was observed for the bottom plate as shown from the side section of the thickness in Fig. 6.

Fig. 4. a) Bottom plate with thorough holes, b) Bottom plate with localized pitting corrosion.

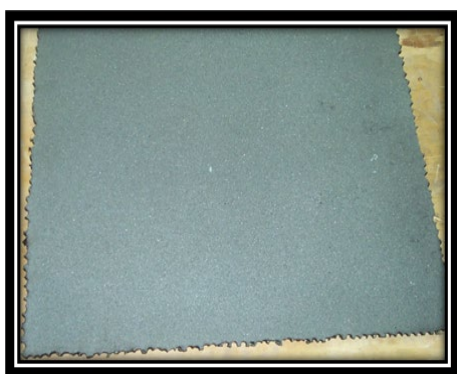
Fig. 5 The free corrosion internal surface.

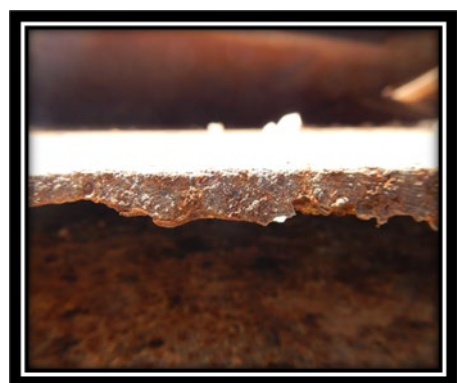
Fig. 6 Side section of the thickness for bottom plate.

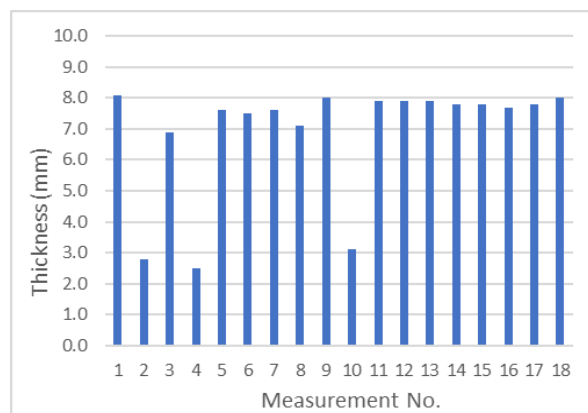
Ultrasonic testing for thickness measurements have been carried out in order to evaluate the tank bottom thickness condition and to evaluate the remaining average thickness for areas of reduction. Thickness readings for different locations were taken for the tank bottom and found that thickness varies from plate to another, for middle area of the tank and away from the center as illustrated in Figs. 7 and 8. The readings showed a huge reduction in thickness in the central area where fuel sludge covered the surface and a through hole was observed. Bottom plate thickness loss at the middle location shows a significant variation, which is out of the acceptable criteria (minimum thickness). This is because of the central area was attacked by localized pitting corrosion. However, the variation in the bottom plates

Fig. 7 Thickness measurements for several locations in the center of the bottom plate.

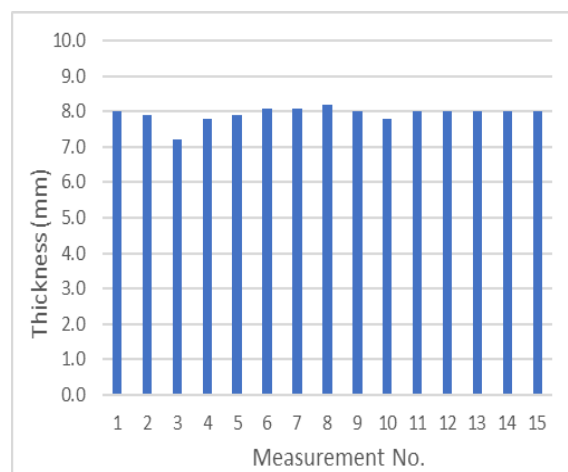
thickness at location away from the center of the tank is consistent, and the loss of thickness is within the acceptable levels. This occurs due to exposed surface was subjected to slow uniform corrosion.

Fig. 8 Thickness measurements for several positions away from the center.

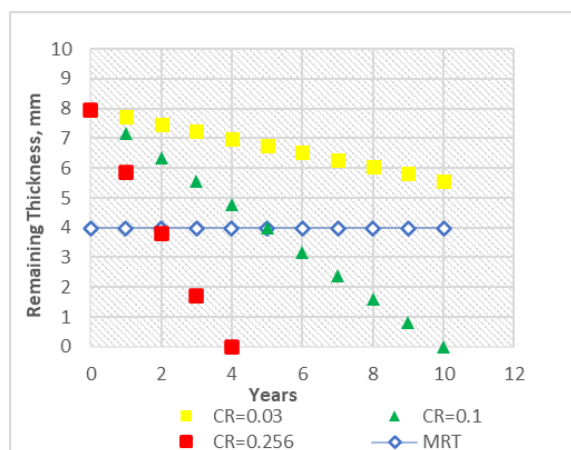
The corrosion rate (CR) was estimated by the formula: $CR = (t_0 - t_i)/T$, where CR = corrosion rate, in mm per year; t_0 = Original thickness (mm), t_i current thickness after (T) years of service, and T = service period of the AST that is 25 years. The minimum acceptable tank bottom plate thickness has to be calculated according to American Petroleum Institute (API) standards 653. The maximum obtained loss of thickness was 6.5mm (only 1.4 mm remaining thickness), and the obtained related corrosion rate (CR), was 0.264 mm/y which seems to be very high corrosion rate according to National Association of Corrosion Engineers (NACE) specification. Other corrosion rates are also determined according to thickness loss based on high loss, average thickness loss, and low thickness loss as shown in Fig. 9. It is noted that the inspection interval should be shortened to two years based on the maximum corrosion rate determined (CR=0.264 mm/y), by considering the minimum remaining thickness (MRT) taken as 50% of the design thickness.

Fig. 9 Various corrosion rate for the tank bottom.

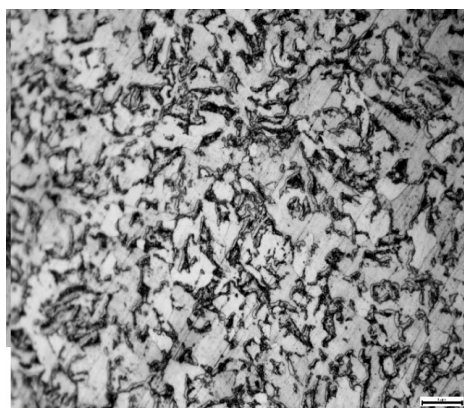
X1 external bottom plate not underneath corrosion

Fig. 10 Free corrosion sample.

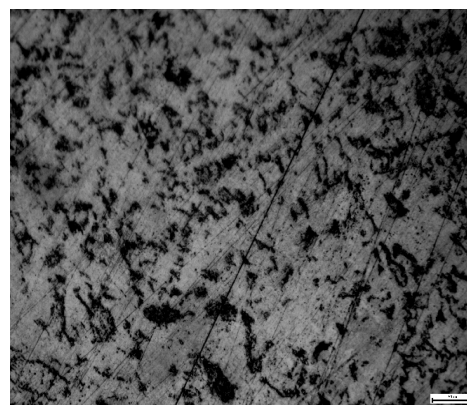
X3 external bottom plate underneath corrosion

The microstructure is composed of ferrite phase and pearlite phase, ferrite (α) is pure iron, and the pearlite is a fine mixture of ferrite and cementite in the lamellar form. The change in the microstructure is observed with an increase in the percentage of ferrite and a decrease in the pearlite areas as shown in the microscopic structure of sample X3 in Fig. 11. It can be the bacterial cells preferentially attached to the grain boundaries are the active points where corrosion typically starts and pearlite which is rich in carbon. The grain boundary is a region of high atomic disorder and this makes it energetically easier for impurities to concentrate at these sites compared to the grain itself.

Fig. 11 Microstructure of the corroded sample.
